# Three-Dimensional Breakwater Stability Tests at Vale de Cavaleiros, Cape Verde

U.S. Army Corps of Engineers  
Waterways Experiment Station  
3909 Halls Ferry Road  
Vicksburg, MS 39180-6199

Final report

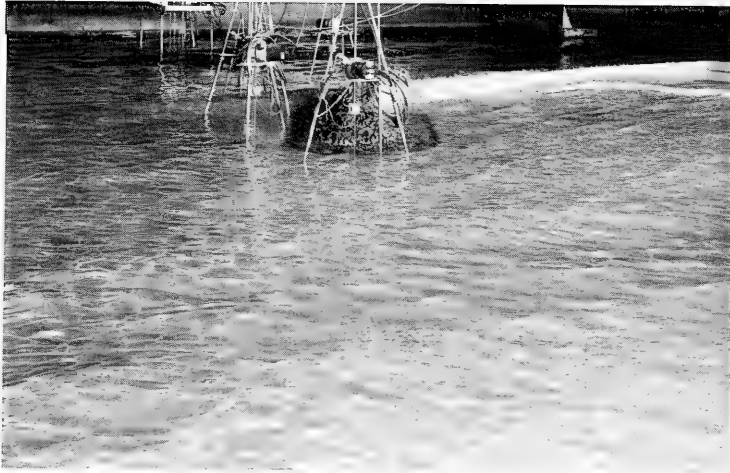
Figure 5. Three-dimensional stability model

Experiments were conducted in a 29.3-m-long, 29.6-m-wide, 1.5-m-deep wave basin. The model was constructed and molded of concrete to represent approximately 825 m of shoreline encompassing the harbor and breakwater location. Contours were molded to -20 m CD, and a 1V on 5H transition slope was molded from the -20-m contour to the model floor elevation of -21.3 m CD. Wave absorber was placed around the perimeter of the basin to minimize the effects of reflection. A photograph of the model is shown in Figure 5.

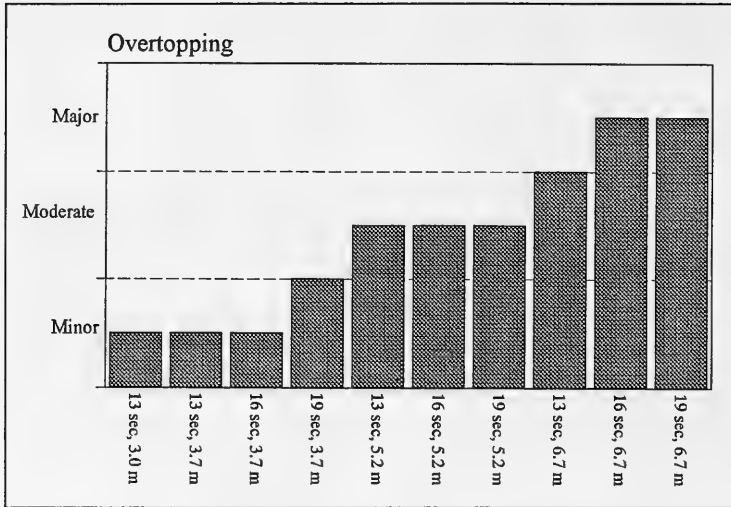
Figure 17. Wave overtopping at trunk, all plans

Overtopping was classified as minor, moderate, or major. Minor overtopping was defined for the present study as occasional or no overtopping. Moderate overtopping was defined as regular overtopping with occasional green water. Conditions that produced frequent overtopping and green water were classified as major.

The classification of overtopping (minor, moderate, or major) is plotted versus wave condition in Figures 17 through 19. The wave conditions in the figures are labeled from left to right by the sequence in which they were generated during the experiment, i.e., 13-sec, 3.0-m waves were generated first and 19-sec, 6.7-m waves were generated last. Figure 17 shows the amount of overtopping that occurred at the trunk for all plans. Major overtopping occurred at the trunk for 16-sec, 6.7-m waves, but was minor or moderate for all other conditions. Figures 18 and 19 show overtopping classifications for Plan 1 and Plan 2 series experiments at the head, respectively. The figures illustrate the reduction of overtopping by raising the crest elevation to +8 m CD (Plan 2 series) from +5 m CD (Plan 1 series).

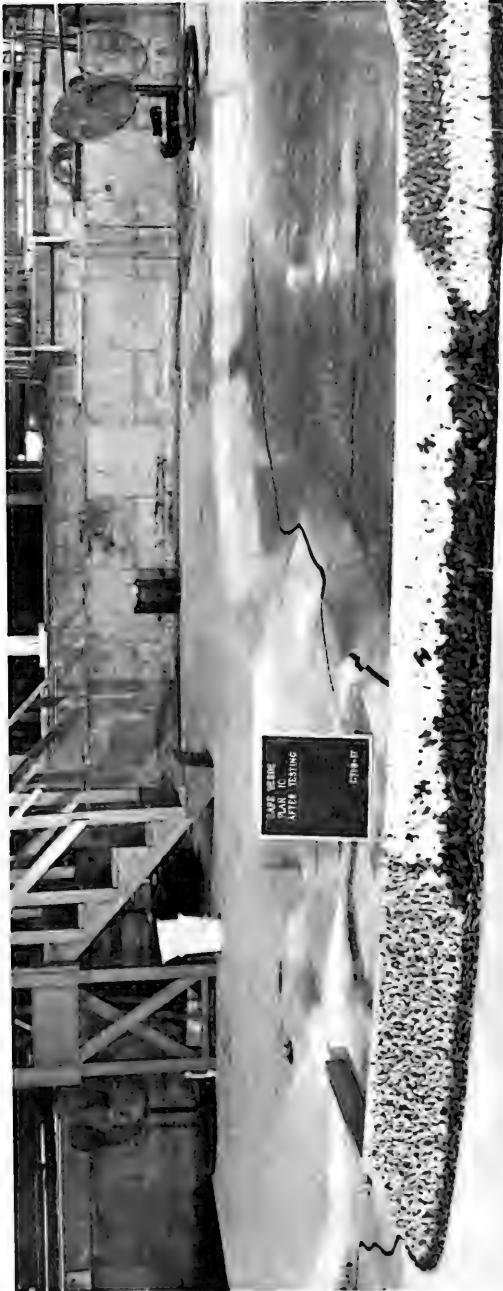
Photo A17. Sea-side view of plan 1C after testing with 19-sec, 6.7-m waves

11-tonne and three 8-tonne toe units were displaced. The toe failed near Profile 10 during 19-sec, 6.7-m waves at a location where the chain was forced seaward between anchors (Photos A17 through A19).

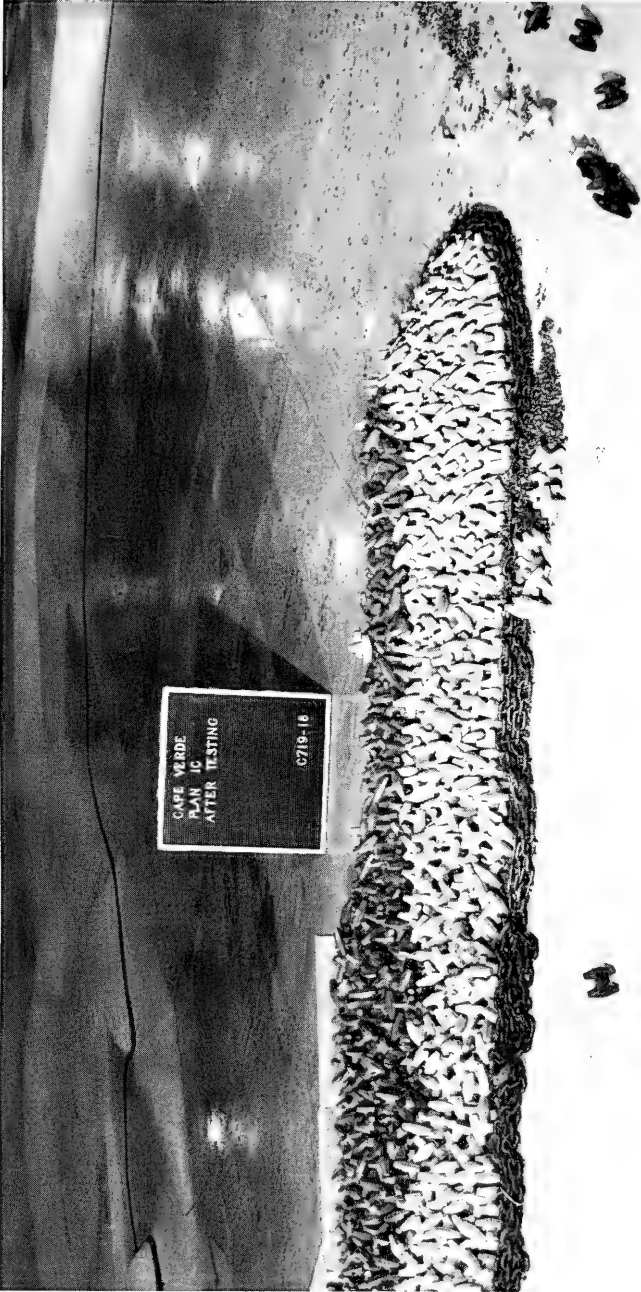
Photo A18. Sea-side view of plan 1C breakwater head before testing with 19-sec, 6.7-m waves

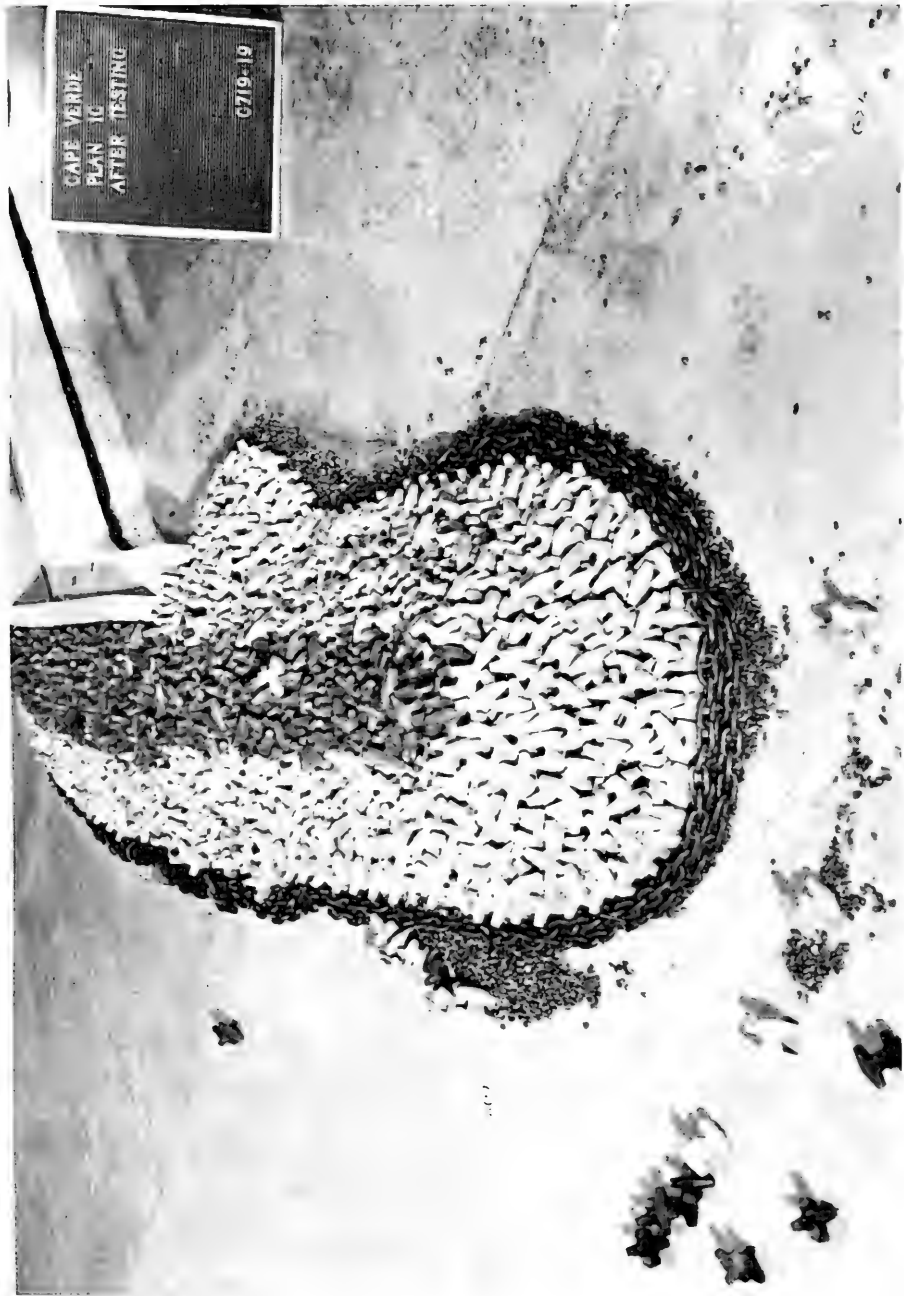
Photo A19. View of plan 1C breakwater head after testing with 19-sec, 6.7-m waves

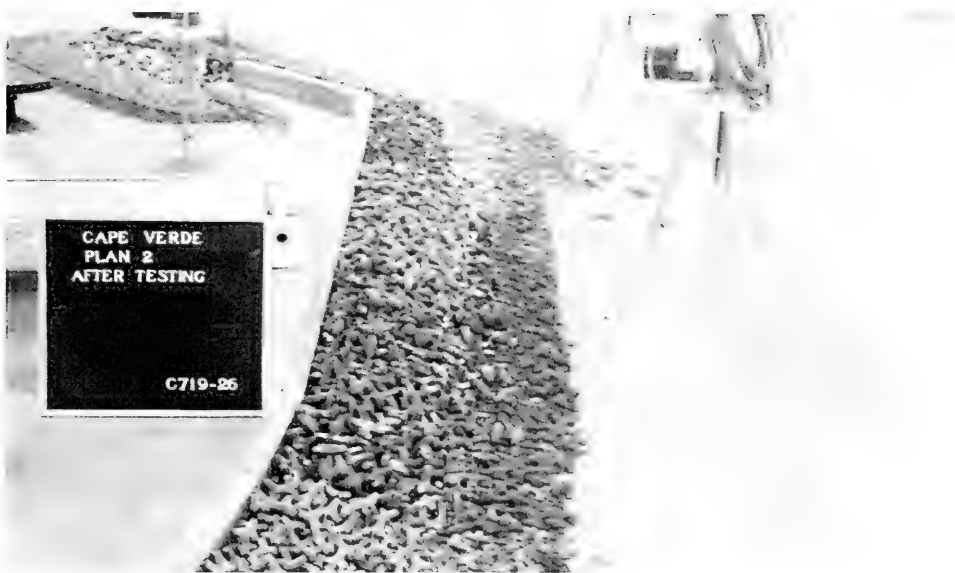
Photo A26. View from north of plan 2 breakwater trunk after testing with 13- and 16-sec, 3.7-m waves

Based on observations of the model and conversations with JV RRI-BCEOM personnel Messrs. A. Merrien and L. Fischer, Plan 2 consisted of raising the +5-m head portion of the breakwater to bring the entire structure to +8 m to reduce overtopping. The 8-tonne units were replaced with 11-tonne Core-Locs and the toe was reinforced with additional 11-tonne units placed in a single row (Figure 13). The packing density of the 11-tonne Core-Locs was 0.62. Toe protection units were placed 90 deg to the toe units of the structure in a manner in which adjacent units interlocked (Photos A23 through A25). The 11-tonne Core-Locs used for toe protection were displaced during 13- and 16-sec, 3.7-m waves, and the armor layer failed due to toe instability (Photos A26 and A27).

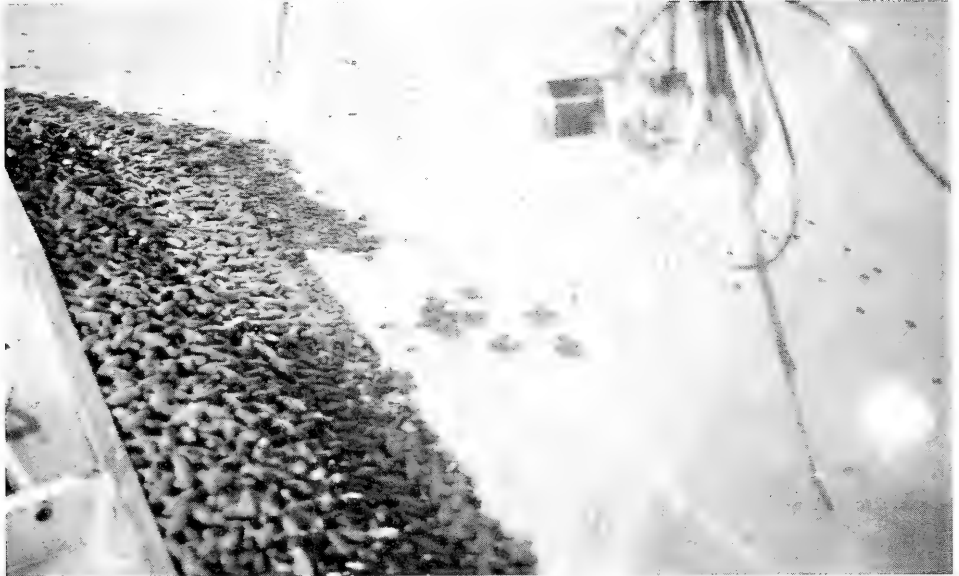
Photo A27. View of plan 2 breakwater trunk, profiles 6 to 8, after testing with 15-sec and 16-sec waves

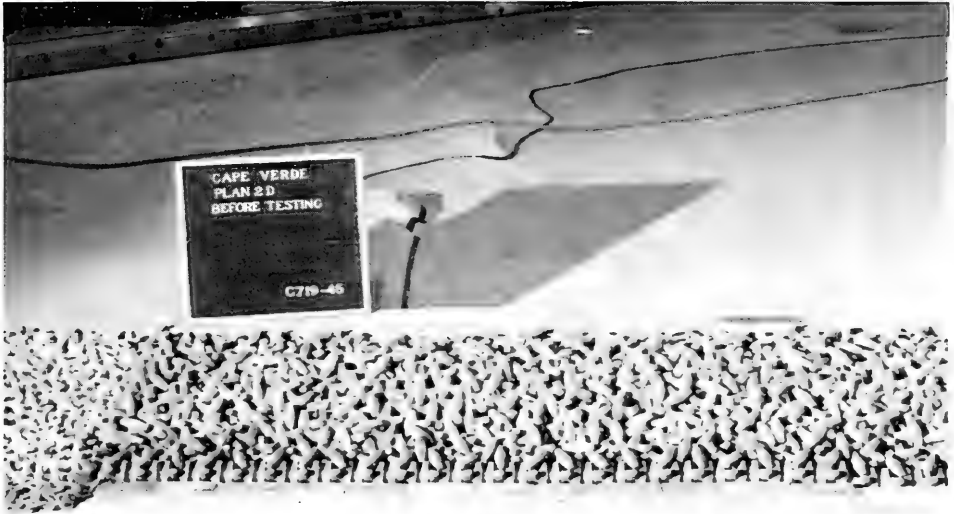
Photo A43. Sea-side view of plan 2D, profiles 4 through 6, before testing

Plan 2D was identical to Plan 2C except the cargo containers were placed end to end along the Core-Loc toe (Figure 16, Photos A43 and A44). The armor layer was rebuilt with a packing density of 0.62. Results were similar to experiments with Plan 2C; the containers began to displace during 13-sec, 3.0-m waves and movement continued with higher waves. Eventually, all containers were displaced from their original position and moved southward along the breakwater. Without toe protection, Core-Loc toe units were displaced and upslope

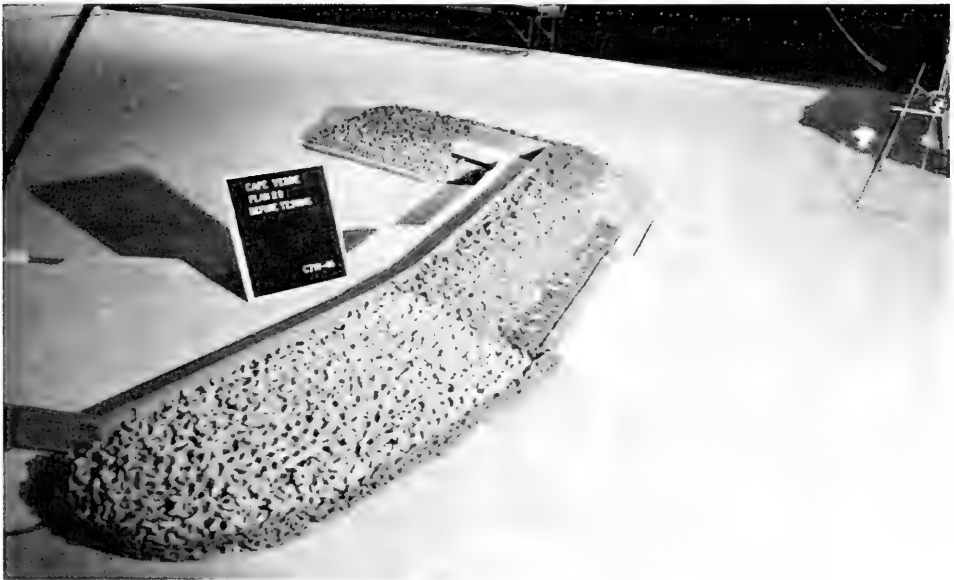
Photo A44. View from north of plan 2D breakwater trunk before testing

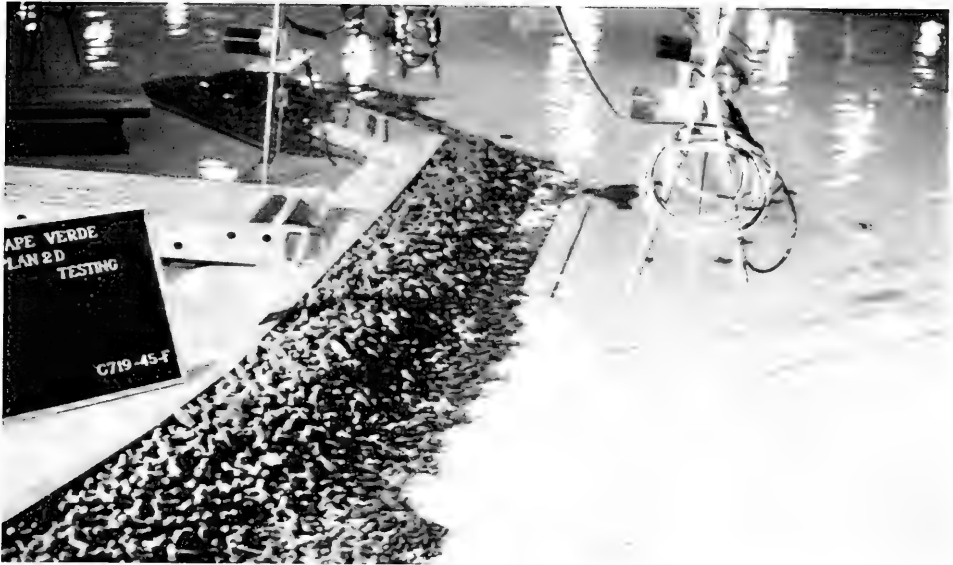
Photo A45. View from north of plan 2D breakwater trunk after testing with total sequence

units settled causing exposure of underlayer stone between Profiles 4 and 5 (Photos A45 and A46).
